Analyzing and Preventing Recurrence of Fatal Electric Arc Accident during Generating Facility Inspection

Analyzing and Preventing Recurrence of Breakage of 220 kV Underground Cable

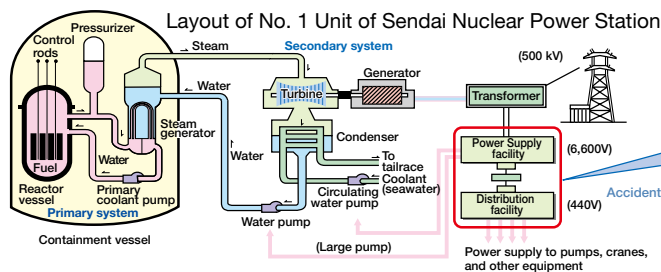
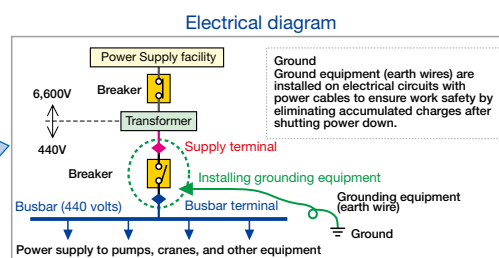
In January 2010, one worker was killed and six were injured owing to an electrical arc during outage work as part of a regular facility inspection at the Sendai Nuclear Power Station.

The accident seems to have stemmed from contact between grounding equipment and a live terminal when the workers were trying to fit an earth wire. This apparently triggered an electrical arc that ignited gas and burned the workers. We assume that several factors combined to cause this accident, including that the workers were insufficiently aware that their job was near a live terminal.

- Describe in the operational procedure manual whether participants have confirmed whether or not a job is near

an electricity source and that voltage from both busbar and supply terminals is detected.

- Label to identify supply and busbar terminals.
- For each task, clearly define the scope of tasks requiring power shutdowns to ensure safety.
- It should be clearly written in work rules that power should be completely off in two circuit locations if at all possible. In principle, work near live electrical sources is prohibited. If working near a live terminal, protective covers and other safety measures shall be used.

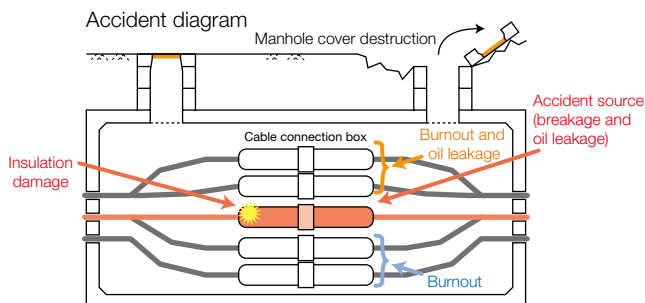
In December 2009, a 220 kV underground cable in Kitakyushu snapped, destroying a manhole cover and damaging the road, nearby houses, and vehicles.

The accident was attributable to cable insulation slippage because of mechanical and thermal stresses, which reduced dielectric strength. The mechanical stress on the cable was caused by installation in an area where there were large curves on a slope, and the thermal stress stemmed from the cable being used in an environment of extremely large daily fluctuation of power flows.

We concluded that cable broke because voltage overwhelmed the dielectric capacity because the charge accumulated on the cable was retransmitted instead of discharging.

- Add discharge confirmation step and operational explanation.
- Improve education and training.
- Add fail-safe function to the computer control system.

Identify locations in which insulation could deteriorate because of similar installation and usage conditions, sampling to conduct destructive checks and assess deterioration.

To ensure that damage to the manhole cover does not cause damage outside the hole if a similar accident occurs, we will strongly connect the cover and entrance of all oil-filled electric cables by FY2011.

We will cover all 220 kV cables in the manholes with highly inflammable tape to prevent fire from spreading between cables. That is because one cable burnt others nearby and increased the damage.
